Acer Travelmate 220 RAM Replacement

Replacement of RAM chips

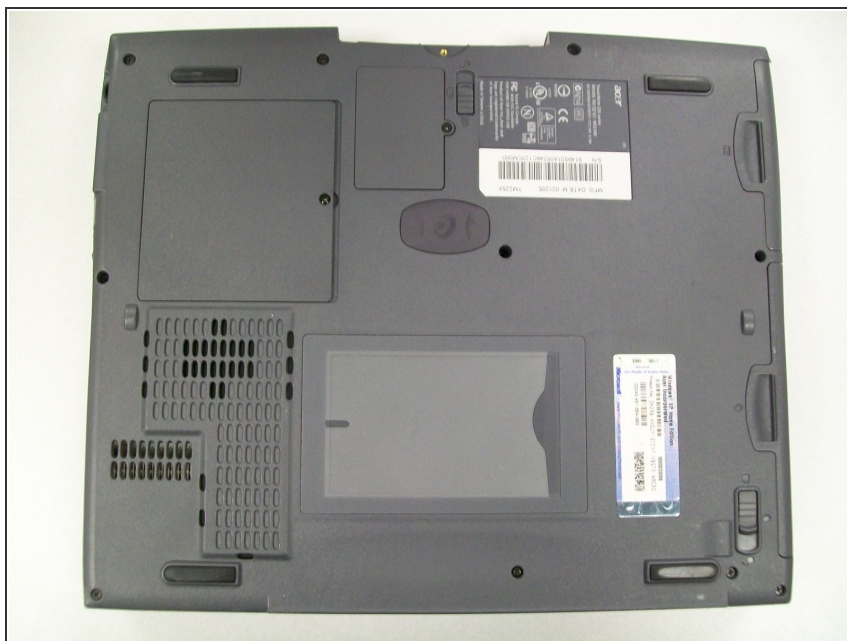
Step 1 — RAM Chip

- Place the computer with the bottom facing up.

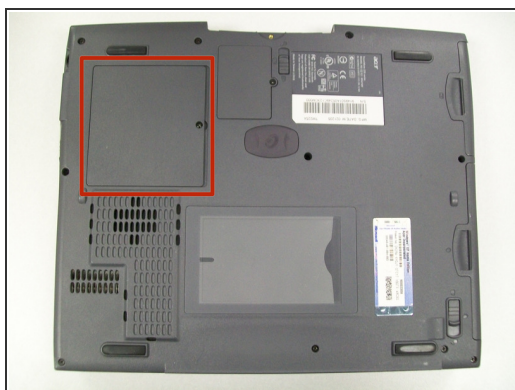
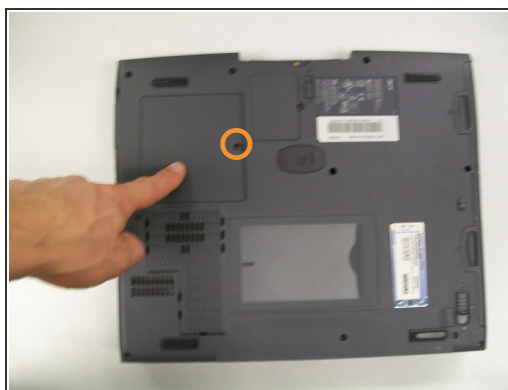
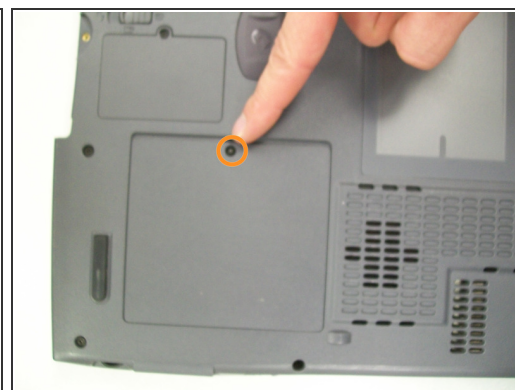
Step 2

- Locate the larger cover panel in the upper left hand corner of the computer.
- Locate the Phillips screw holding the large cover panel in place.

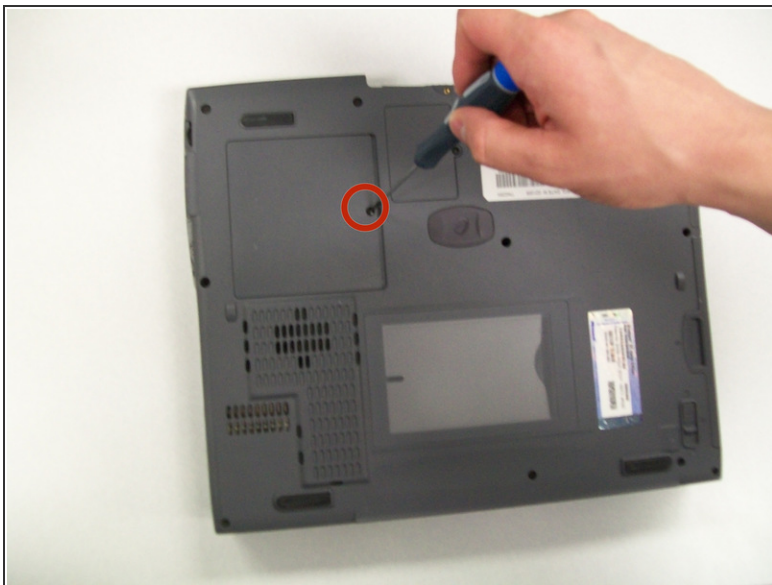
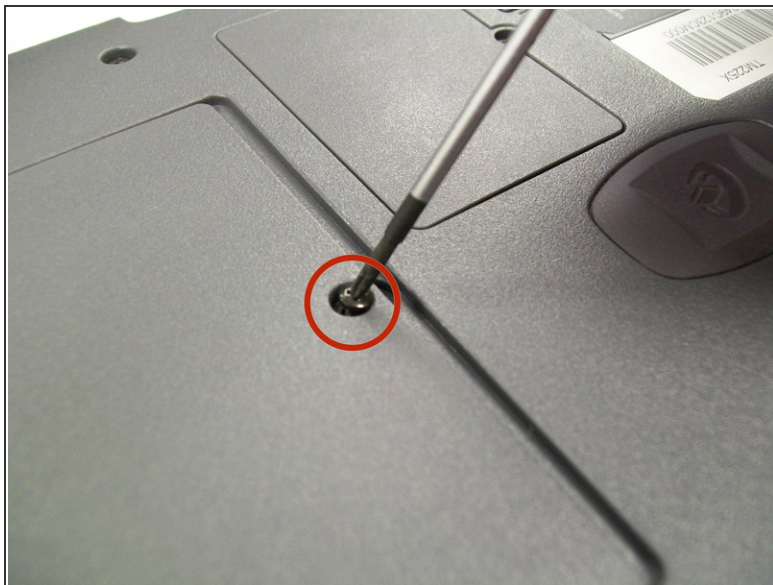
Step 3

- Remove the located screw with the Phillips #00 screwdriver.

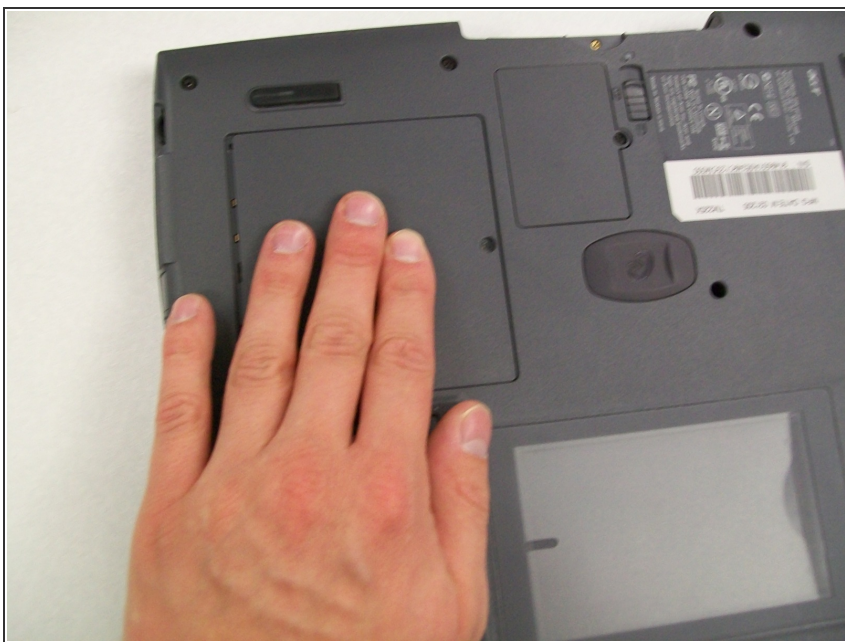
Step 4

- Slide the large cover panel to the right, until you hear a click.

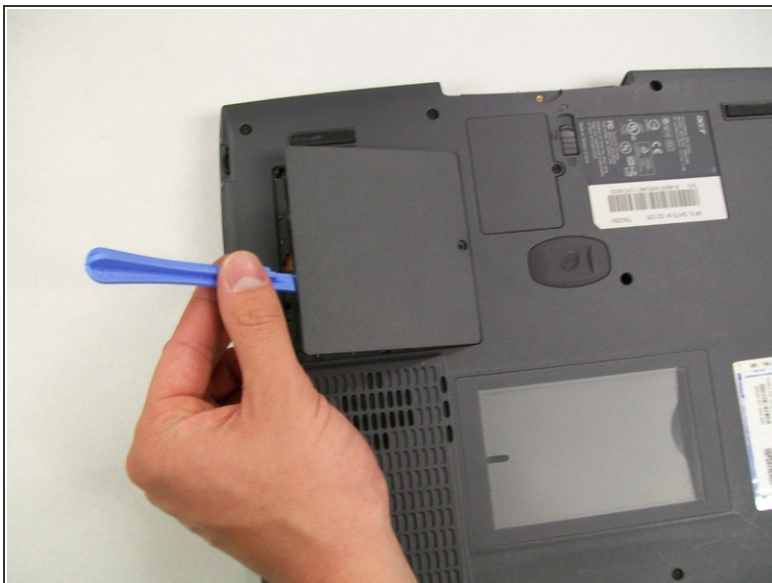
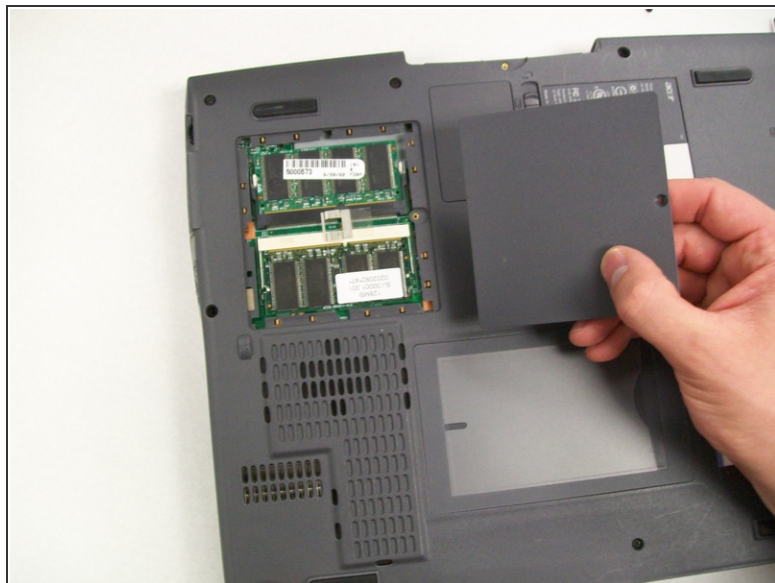
Step 5

- Place the plastic opening tool in the gap created to the left of the large cover panel.
- Pry the cover panel up and remove it from the computer.

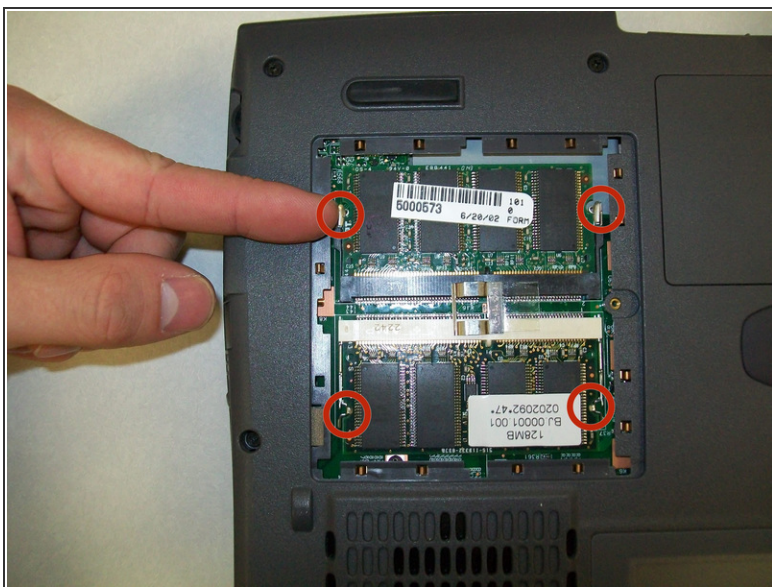
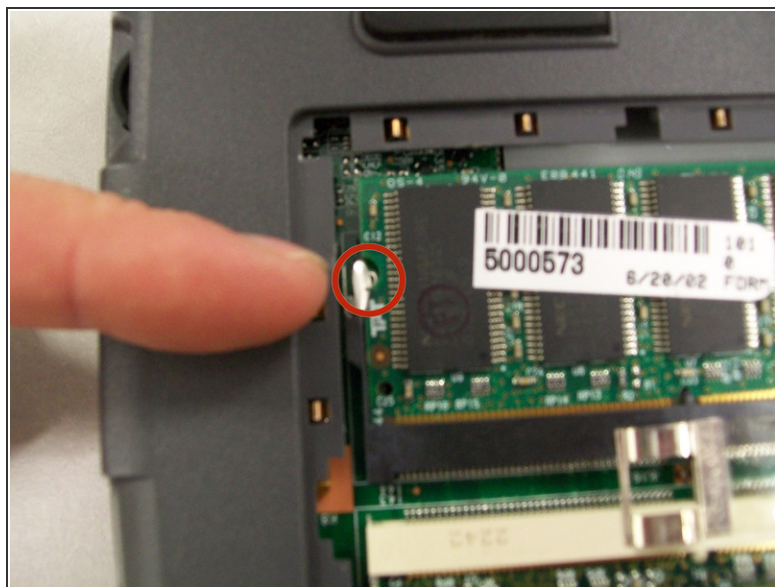
Step 6

- Locate the white plastic levers on each side of the two RAM chips.

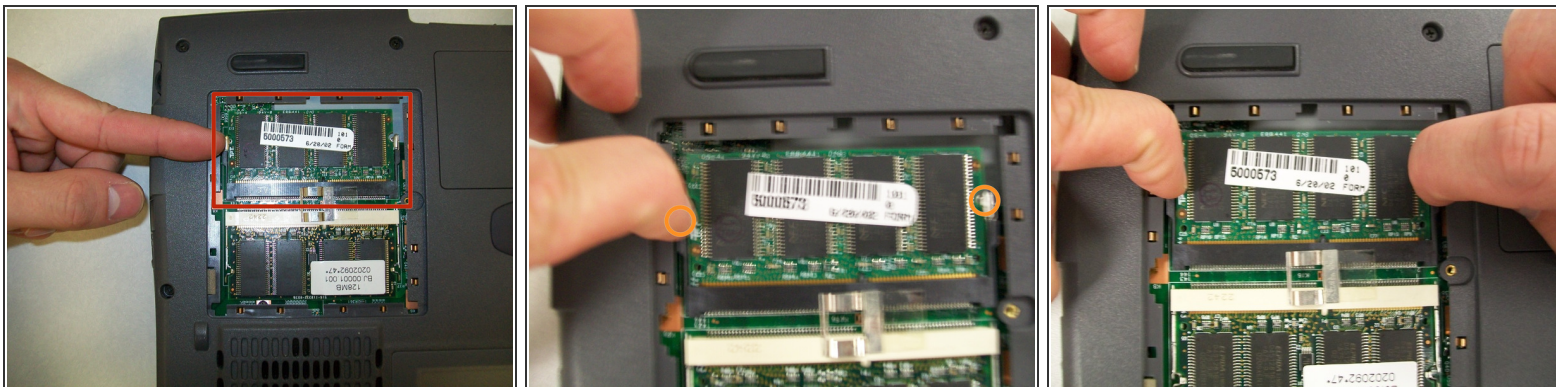
Step 7

- Locate the first RAM chip.
- Push the plastic levers away from the first RAM chip.

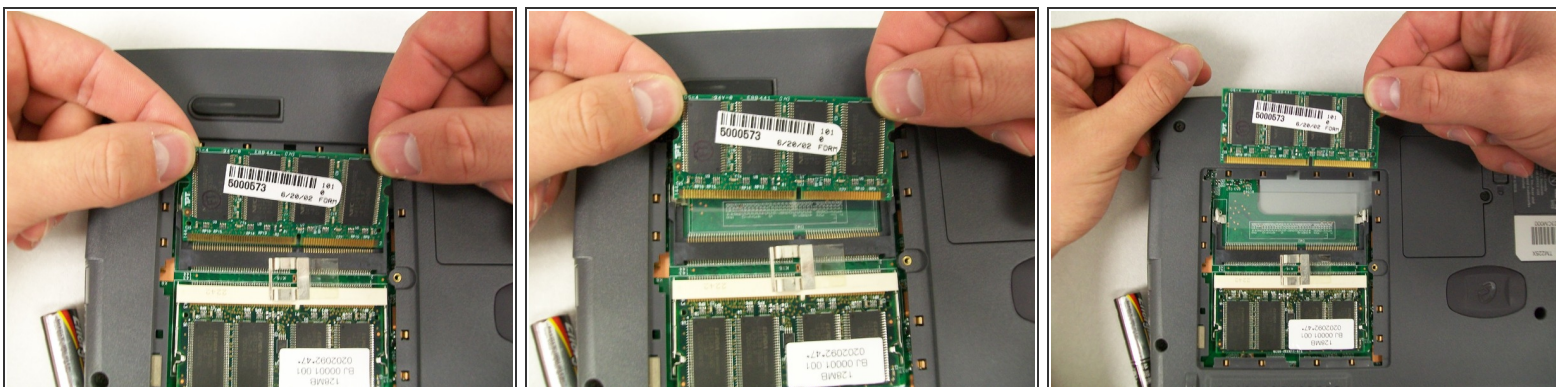
Step 8

- Lift the RAM chip from the compartment.
- Repeat steps 7 and 8 to replace the second RAM chip.
